PIKES CREEK DAM

NDS ID NO. PA-00576

PHASE I INSPECTION REPORT
NATIONAL DAM INSPECTION PROGRAM

JULY 1978

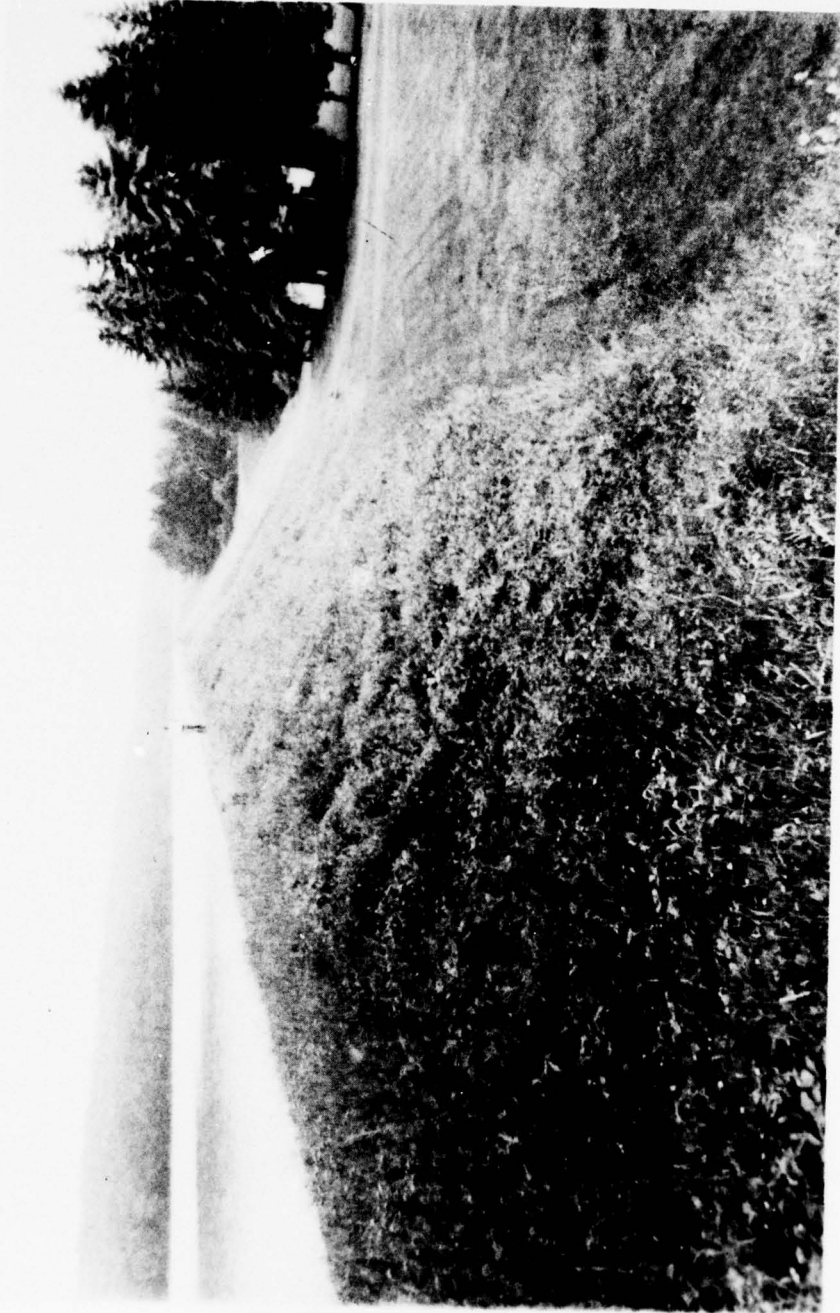
View of Embankment from
Main Spillway at Right Abutment

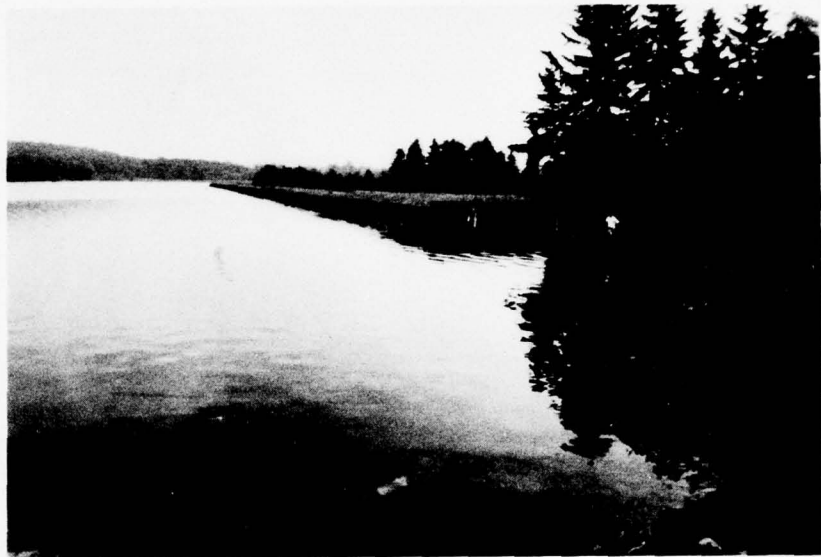
A. Embankment and Main Spillway
View from Right Abutment

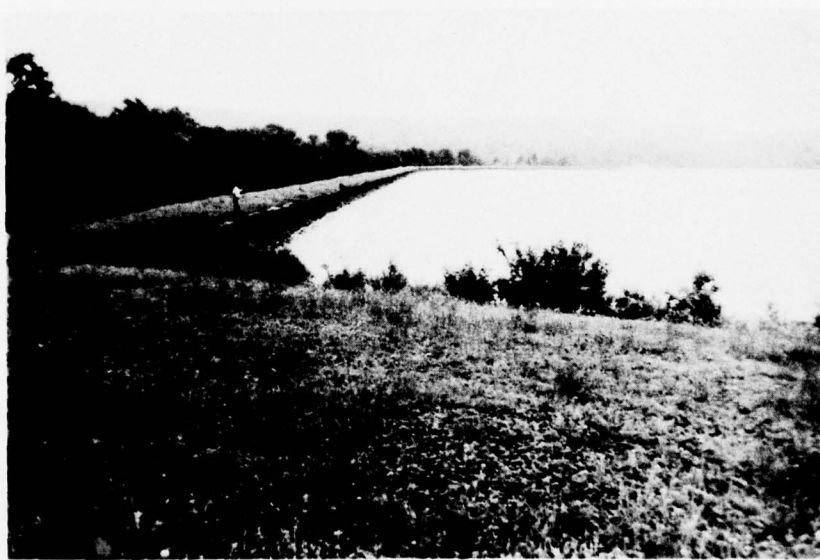
B. Embankment — View from
Auxiliary Spillway at Left Abutment

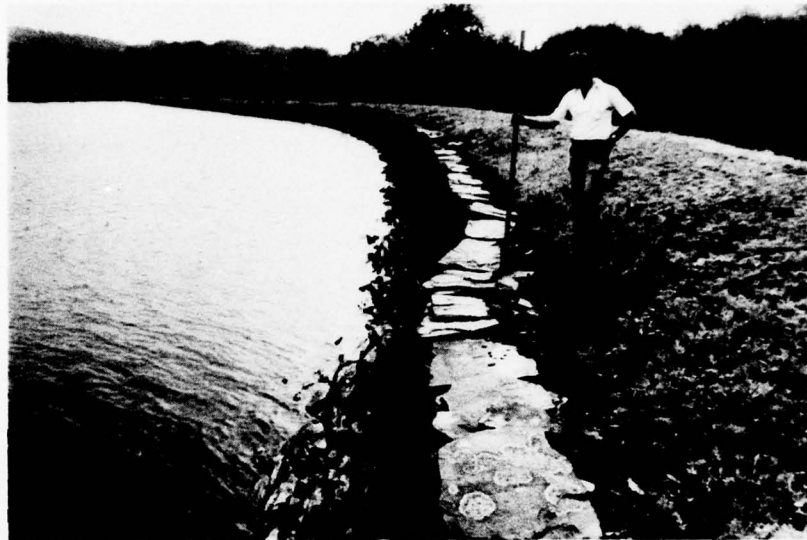
C. Riprap on Upstream Slope

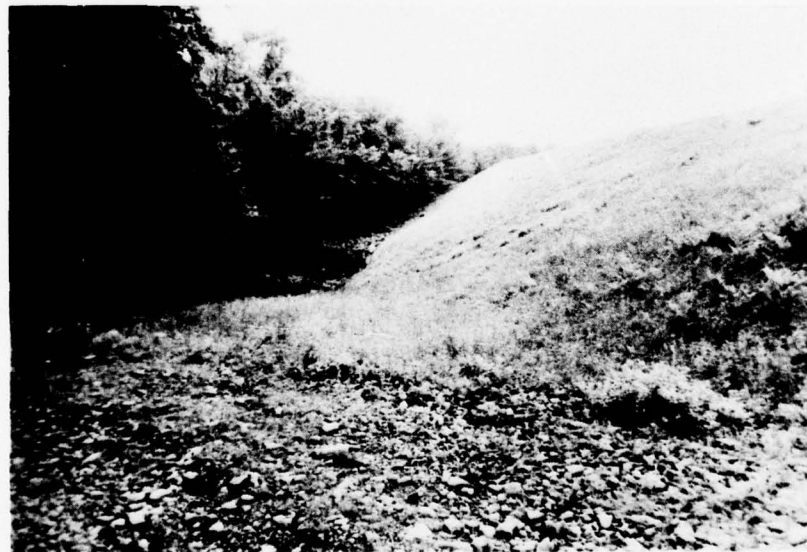
b. Embankment. The sod on the embankment is in excellent condition. There are a number of holes, made by burrowing animals, in the embankment. A number of turtles were observed making holes to lay eggs in. Some other holes were observed to be of a size suitable only for small rodent-sized animals. A few larger holes were observed. None of the larger holes appeared to be active. The vertical alignment of the dam is uneven, with the lowest elevation being 1055.9. These low spots are not localized but extend over most of the dam, except at the abutments. One 10-foot long section of rip-rap on the upstream slope of the embankment is bulged toward the reservoir (Photograph C). The dry masonry wall at the downstream toe of embankment near the valve house is bulged. The center of the wall protrudes about 6 inches further downstream than the ends. Along lengths of the downstream toe, the tree line is at the toe. Some surface cracking was observed on the top of dam. One crack extended normal to the centerline of dam across the entire top. Another crack extended longitudinally for about 100 feet. This crack appeared intermittent. These cracks were very fine and their depth could not be measured. No relative movement was observed at the cracks. Seepage was observed at three separate areas along the downstream toe. One area (Photograph D) was near the left abutment. This area measured approximately 225 feet along the toe and extended about 300 feet downstream of the toe. The area was irregular in shape and had a swampy surface. Water was observed over most of the area. A low artificial pond was also observed in the middle of the wet area. Clear seepage of about 15 gpm was observed flowing from the wet area. The Owner reports that the water in this area is coming from the left abutment hillside. He reports that the pond was originally used to store bait. A second seepage area, about 1 square foot, exists 150 feet left of the valve house. Clear water was seeping from this area at the rate of about 1 gpm. A dry erosion gully extends from the embankment berm to this area. A third seepage area was observed at the valve house. The source of the seepage was not evident. Water was clear and flowing at a rate of about 10 gpm. The Owner reported that the source of the seepage was leakage from the defective packing on the valves in the valve house.

D. Embankment and Wet Area
Near Left Abutment

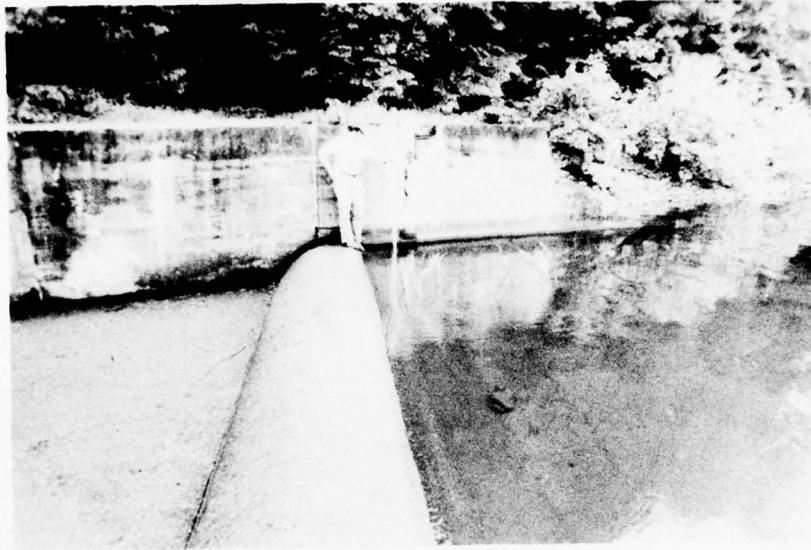
c. Main Spillway. The concrete weir of the main spillway is in generally good condition (Photograph E). The weir was placed in two 36-foot long monoliths. Shrinkage cracks are evident. The aggregate is exposed on the weir. The right approach wall is cracked (Photograph E). Evidence of relative movement was observed. The approach channel slab has a crack, parallel to the weir, extending across the entire slab. The flume downstream of the weir is in generally good condition. Two of the monoliths in the bottom of the flume are pitted over most of their area. The concrete walls were constructed as 30-foot long monoliths and numerous shrinkage cracks were observed. At the cracks there was evidence of slight leaching, as white deposits or "efflorescence" was observed. The toe of the wall stem is slightly scoured along the entire length. The top of the walls are slightly spalled in spots. At a few joints, the concrete has spalled to a depth of about 2 inches over an average length of 5 inches. The reinforcing bars, which appear to extend continuously between monoliths, are exposed in these areas. Trees are very close to the left wall. The branches hang over part of the flume. The inspection of the flume ceased about 500 feet downstream of the spillway crest.

b. Main Spillway. The crack in the right approach wall of the main spillway was probably caused by settlement. The crack in the approach channel apron may be related to settlement or may have been caused by ice pressure. Neither condition presents an immediate hazard to the dam. The shrinkage cracks were probably caused by the excessive monolith

lengths. The other deficiencies noted in the concrete are to be expected after long term exposure to the weather and to flowing water. Long term neglect will lead to further deterioration of the concrete and deterioration of the exposed reinforcing bars. Trees close to the walls are undesirable.

E. Main Spillway Crest and
Main Spillway Right Training Wall

(4) Visually monitor surface cracking, spalling, shrinkage cracks, and pitting in the main spillway walls and apron, auxiliary spillway walls, and outlet works headwall. Areas where reinforcing bars are exposed and areas where concrete is severely disintegrated should be repaired.

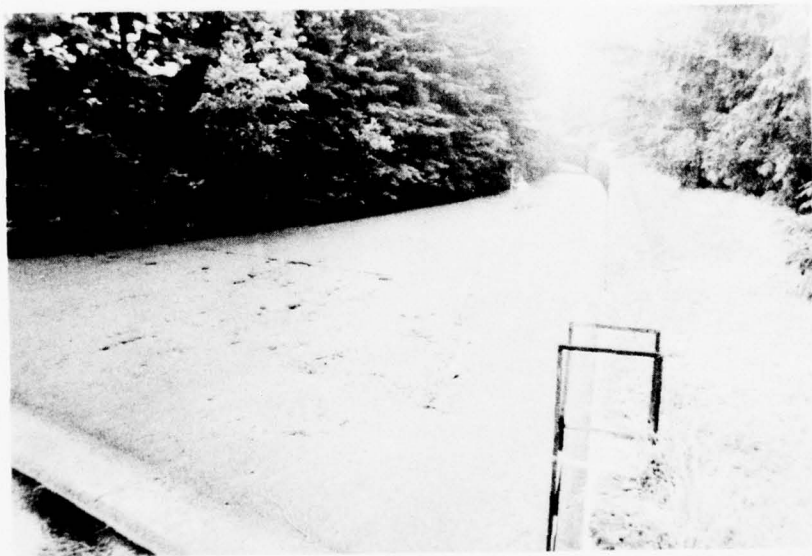
F. Main Spillway Channel

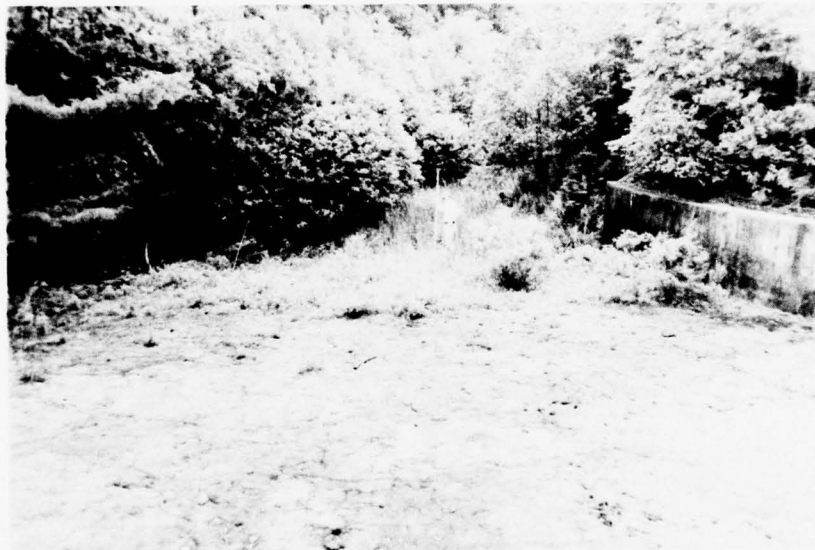
c. Visual Observations. During the inspection of Pikes Creek Dam, it was observed that the channel downstream of the auxiliary spillway was heavily overgrown. This vegetation could cause backwater to reduce the auxiliary spillway discharge capacity. It was also estimated that Harveys Creek Canal was hydraulically unable to pass large flows from the auxiliary spillway. As Harveys Creek Canal does not present a hazard to the dam, this condition was only of slight concern. No habitations were observed near Harveys Creek Canal.

H. Auxiliary Spillway Channel

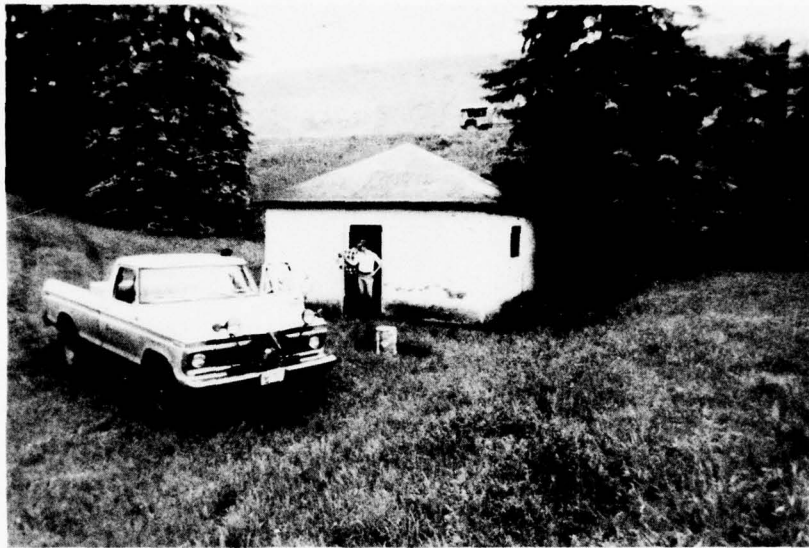
e. Outlet Works. The headwall is slightly spalled along the exposed edges and more heavily spalled at the downstream end of the walls. One 4-inch square pitted area was observed. The valve packings in the valve house leak. The position indicator on the right valve was missing. The operation of the valves was observed. It required four men turning a 30-inch diameter handwheel to operate the valve. It is estimated that it would require about 1 hour to fully open a valve manually. The Owner supplied an air compressor and attachments to operate the valves. It took two men 20 minutes to fully open a valve. All valves are operational.

I. Valve House — Embankment in Background

(5) Repair leaking valve packings.

(6) Replace missing valve position indicator.

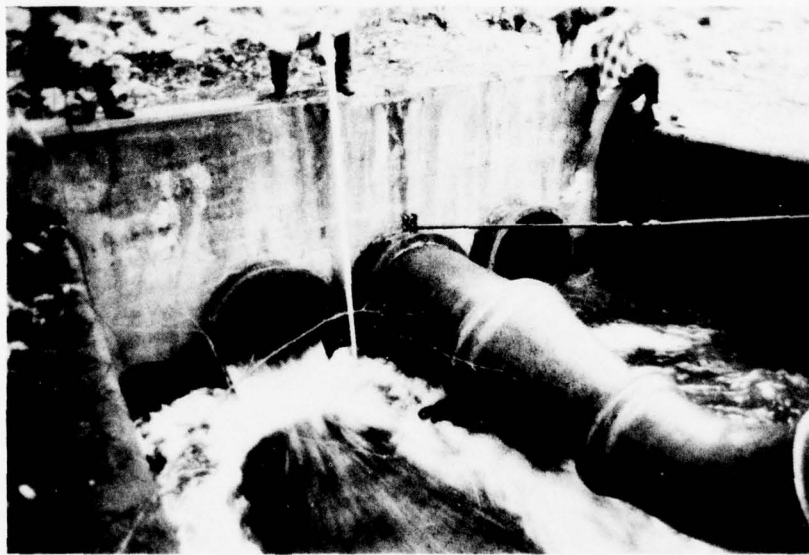
d. Outlet Works. The spalling and pitted concrete observed is usual after long-term exposure to the weather and to flowing water. Leaking valve packings are undesirable. The operation of the valves was satisfactory. It would be desirable to have position indicators on all valves.

J. Outlet Works Headwall
